Camlin Catchment Review

Version: 8th November 2021

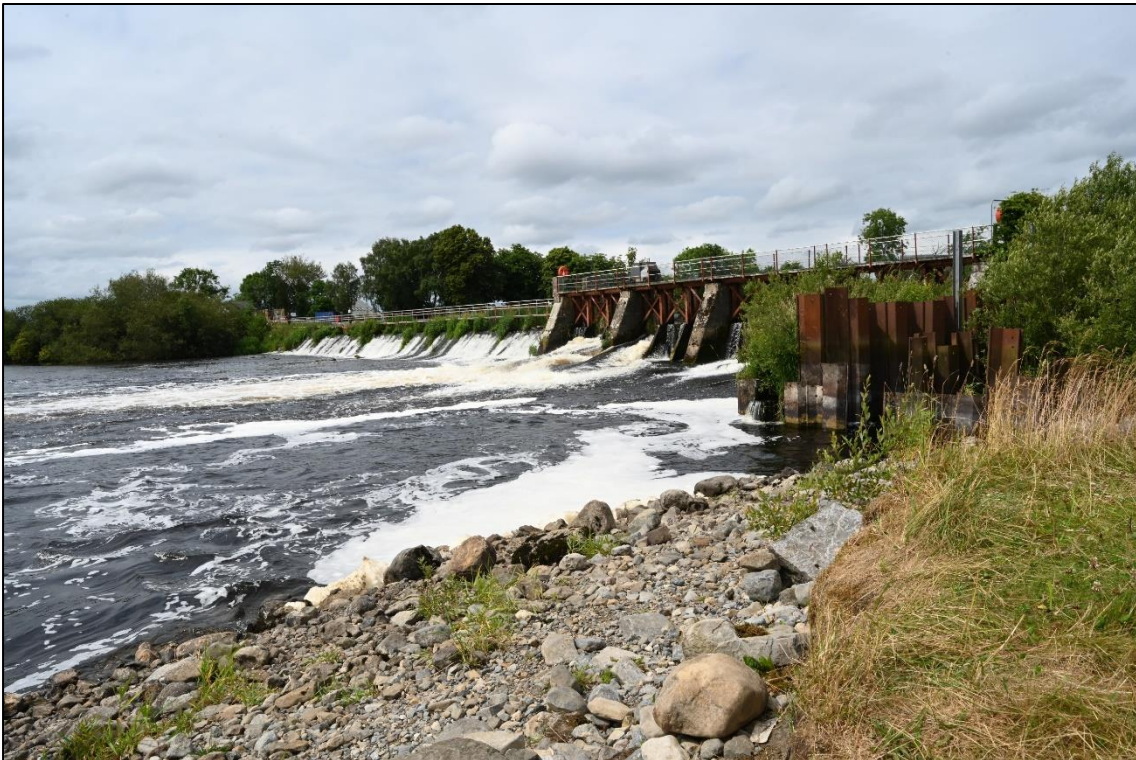
Plate 1 Termonbarry Weir on the Upper River Shannon directly upstream of where the River Camlin joins the river.

Another weir is situated c. 0.5km upstream, outside the village of Termonbarry, Co. Roscommon, where the Camlin River meets the River Shannon. Ecofact (2016) has described this weir as a barrier that “contributes to the general absence of Salmon in the upper reaches of the River Shannon” and have stated that it needs to be updated. This is a barrier to fish migration up the River Shannon.

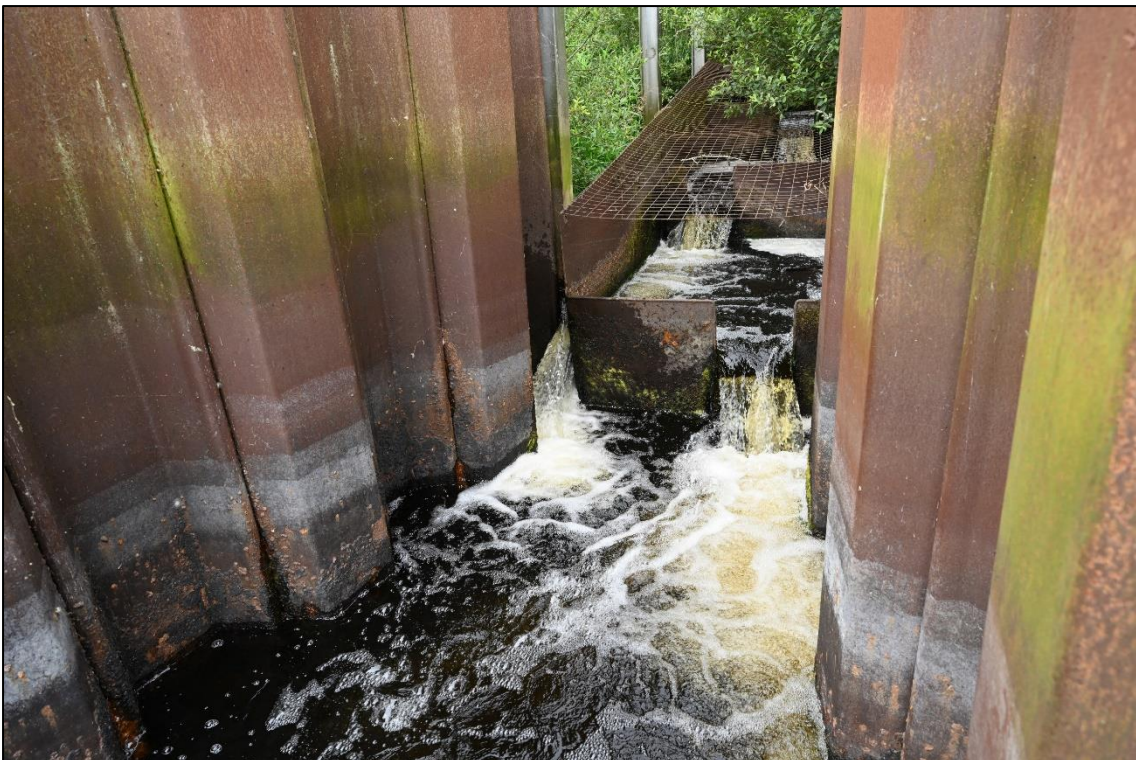
Plate 2 Non-functional fish pass at Termonbarry Weir.

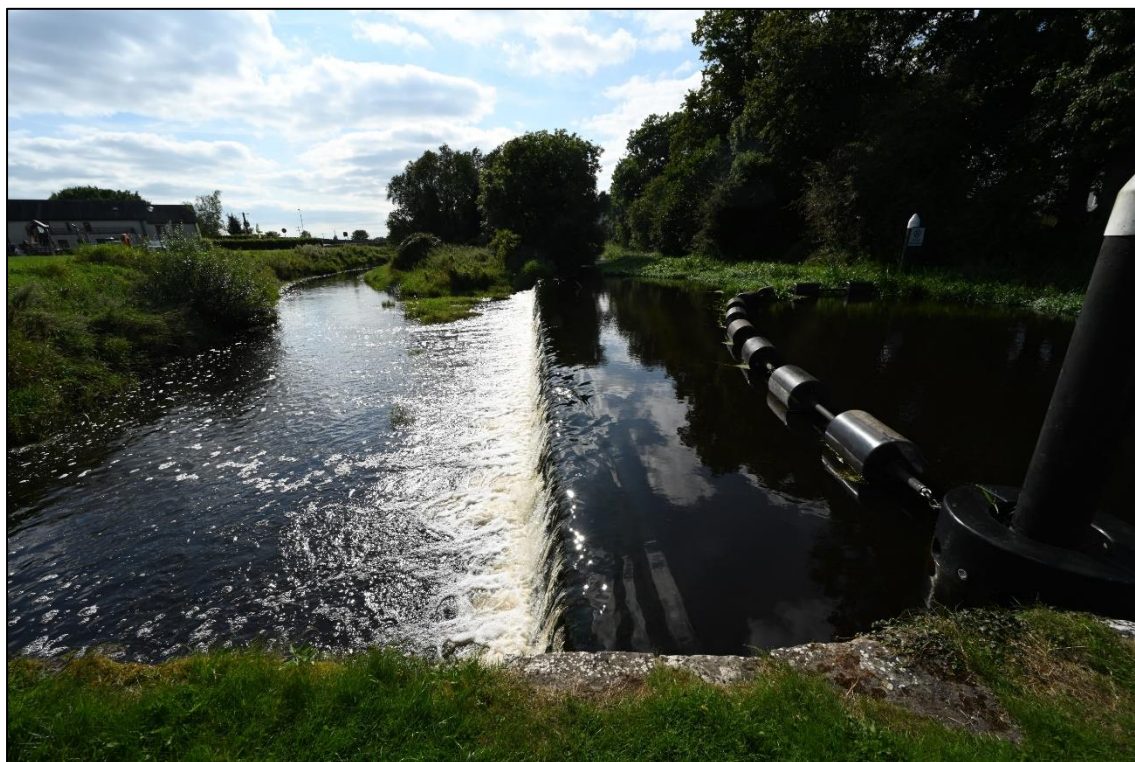
Plate 3 Navigational Weir on the River Camlin at Cloondara. One of the migration barriers in the catchment.

There is a weir on the lower River Camlin, outside the townland of Cloondara. This weir was built in the 1770's. The weir is c. 1.1rkm upstream from where the River Camlin meets the River Shannon. There is an EPA monitoring station (EPA station code: RSRS26C011100) c. 0.1rkm downstream of the weir. The 2020 Q rating was Q3. There is also a lock, named Bourke's Lock, outside Cloondara on an artificial canal. This is located c. 0.35rkm upstream from where the Camlin River meets the River Shannon.

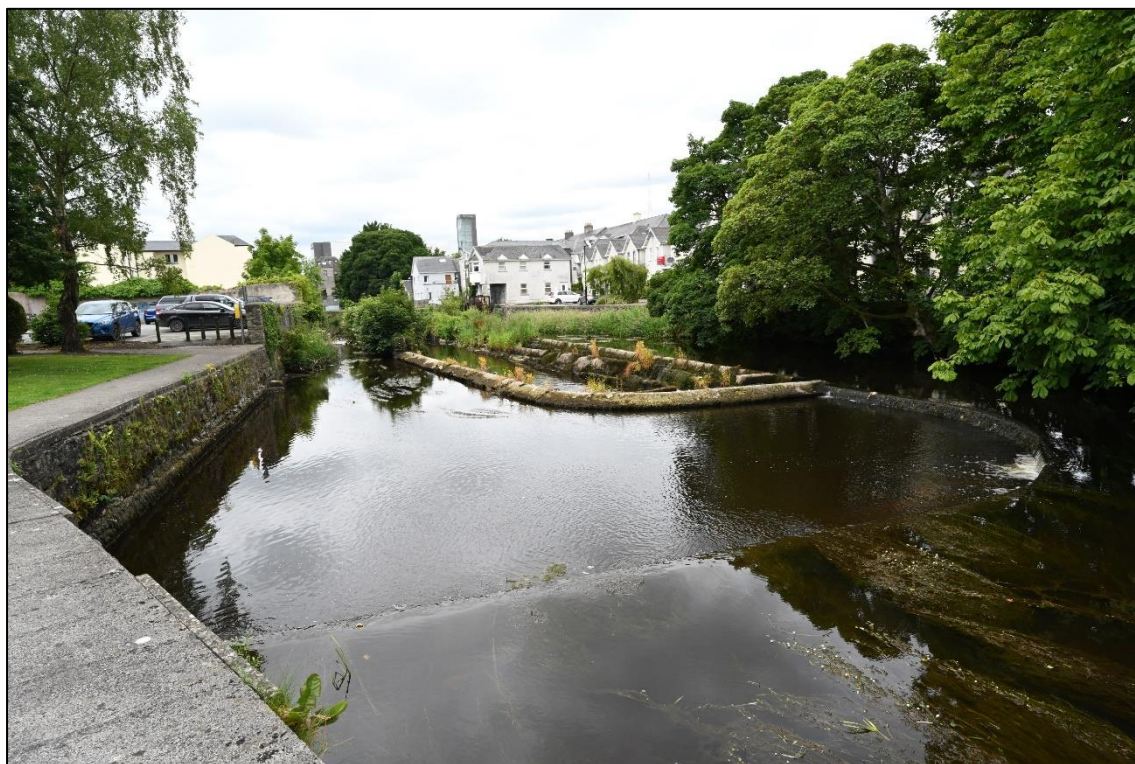
Plate 5 Weir at Longford Town – another barrier to upstream migration.

Dams, barriers, locks and weirs are causing significant barriers to upstream migration. Two major barriers are located at Termonbarry Weir on the River Shannon [Upper] and also Longford town weir. Another barrier has been identified on the L1063 road upstream of Ballinallee. An assessment of the migration barriers in the area could be undertaken to better understand the connectivity of the Camlin catchment and so that mitigation can be put in place to aid migration.

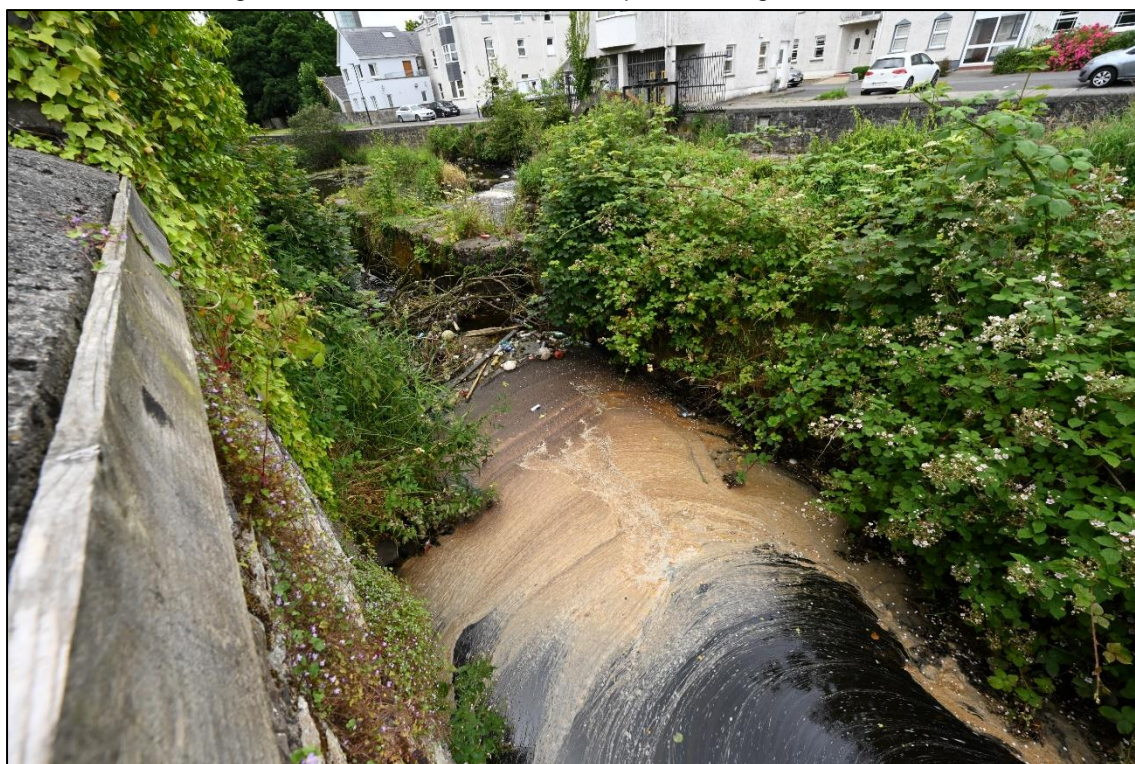
Plate 6 Evidence of littering and scum on the water surface near Longford town weir.

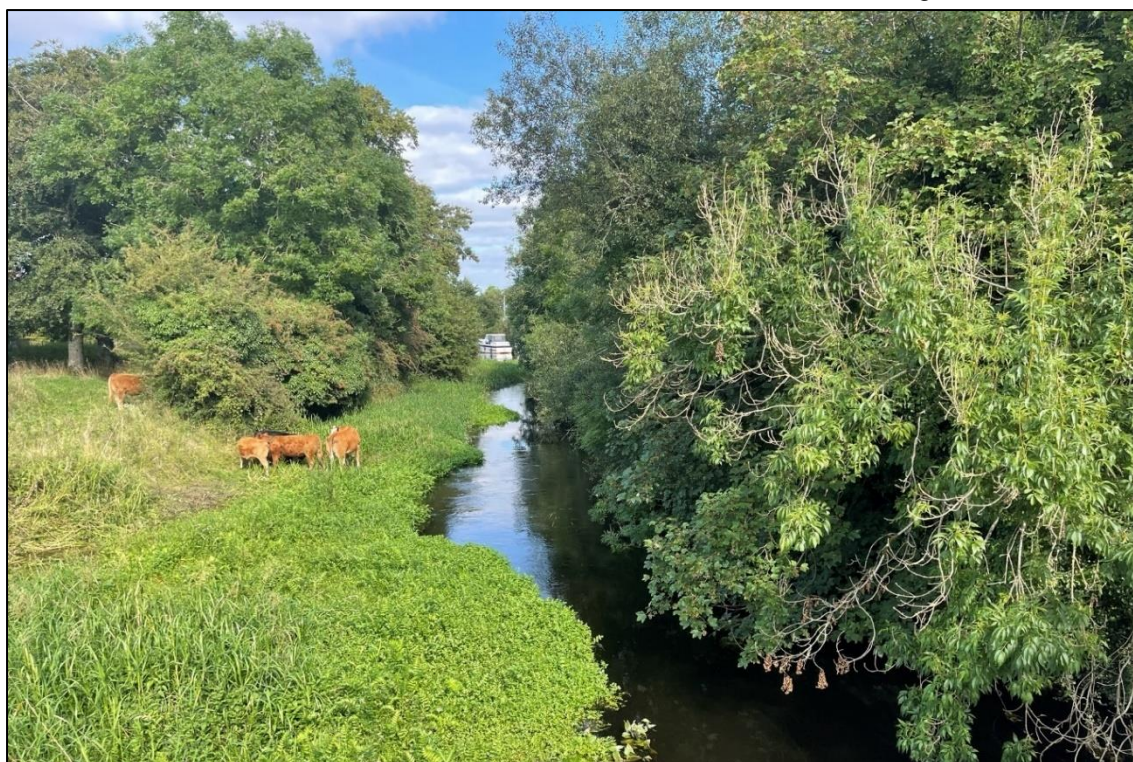
Plate 8 EPA monitoring station RS26C011100 on the 4th order River Camlin. This site was rated Q3 in 2020.

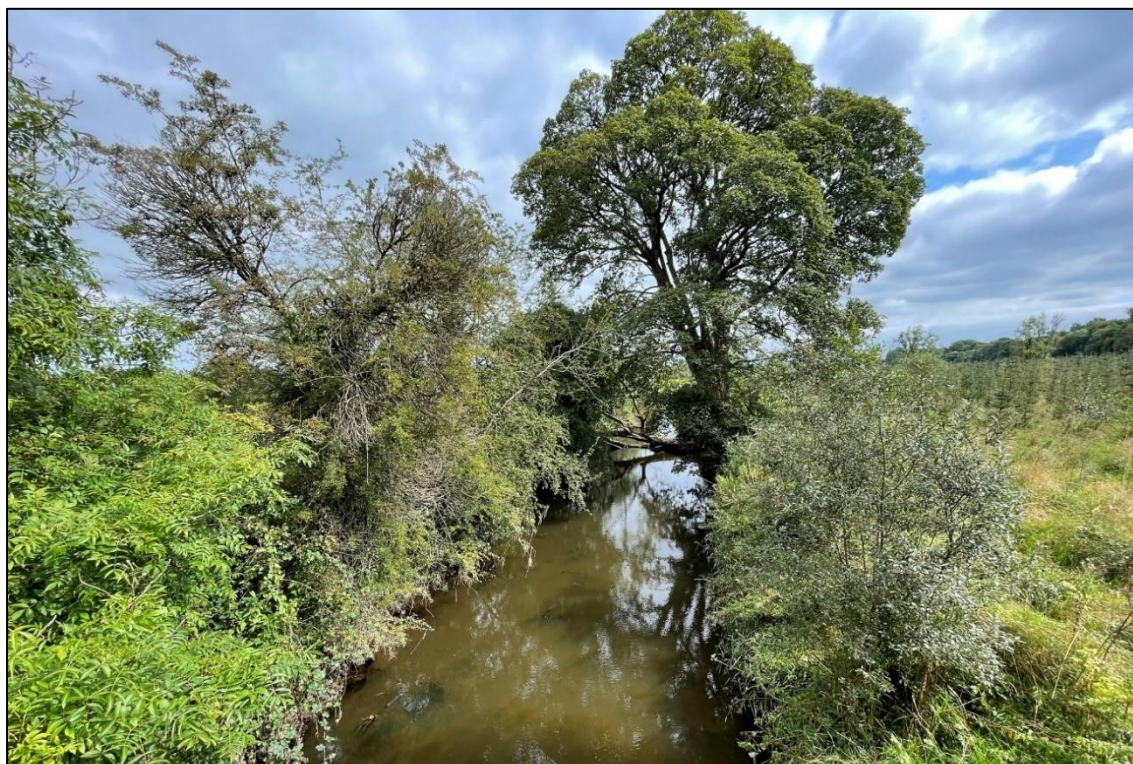
Plate 9 EPA monitoring station RS26C010700 on the River Camlin. The most recent Q rating is from 2020 and was Q3-4. This is a decline on the previous rating of Q4-5 in 2017.

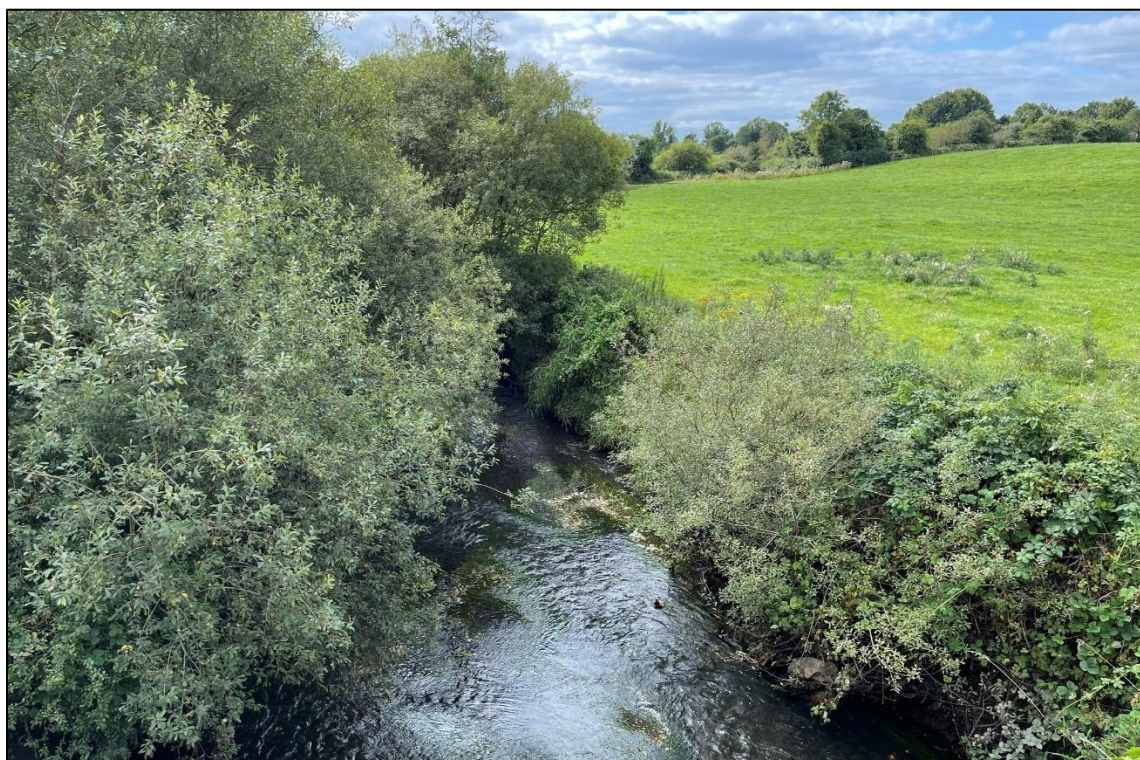
Plate 10 EPA monitoring station RS26C010600 on the River Camlin. The most recent Q rating is from 2020 and was Q4. This is a decline on the previous rating of Q4-5 in 2017.

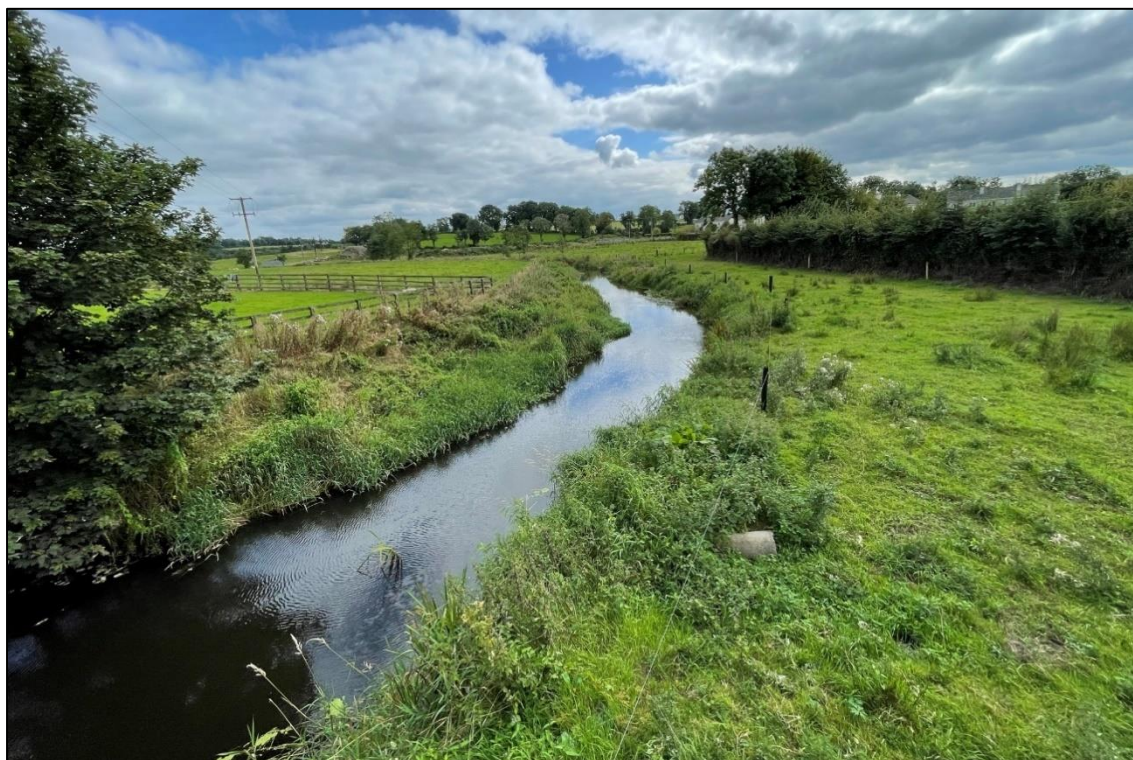
Plate 11 EPA monitoring station RS26C010200 on the River Camlin. This site was rated Q3-4 in 2020 declining from 4-5 in 2017.

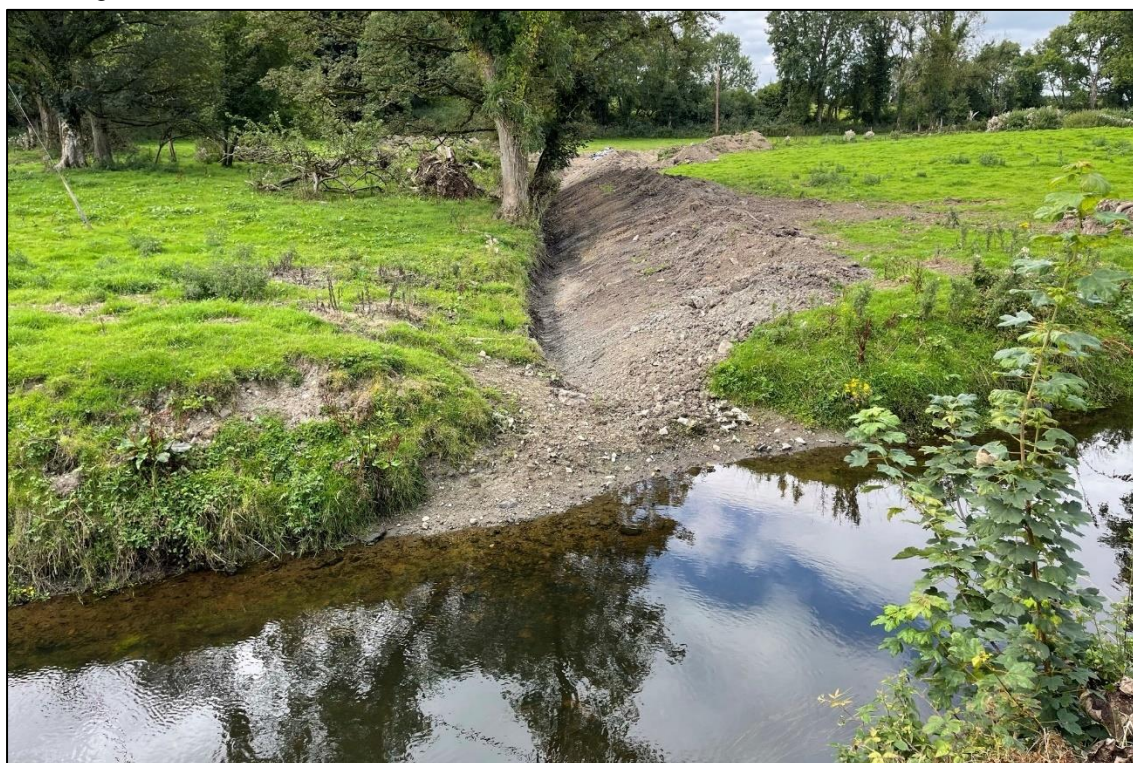
Plate 12 EPA monitoring station RS26C010200 on the River Camlin. There was evidence of a drain being dug out and recent soil excavation.

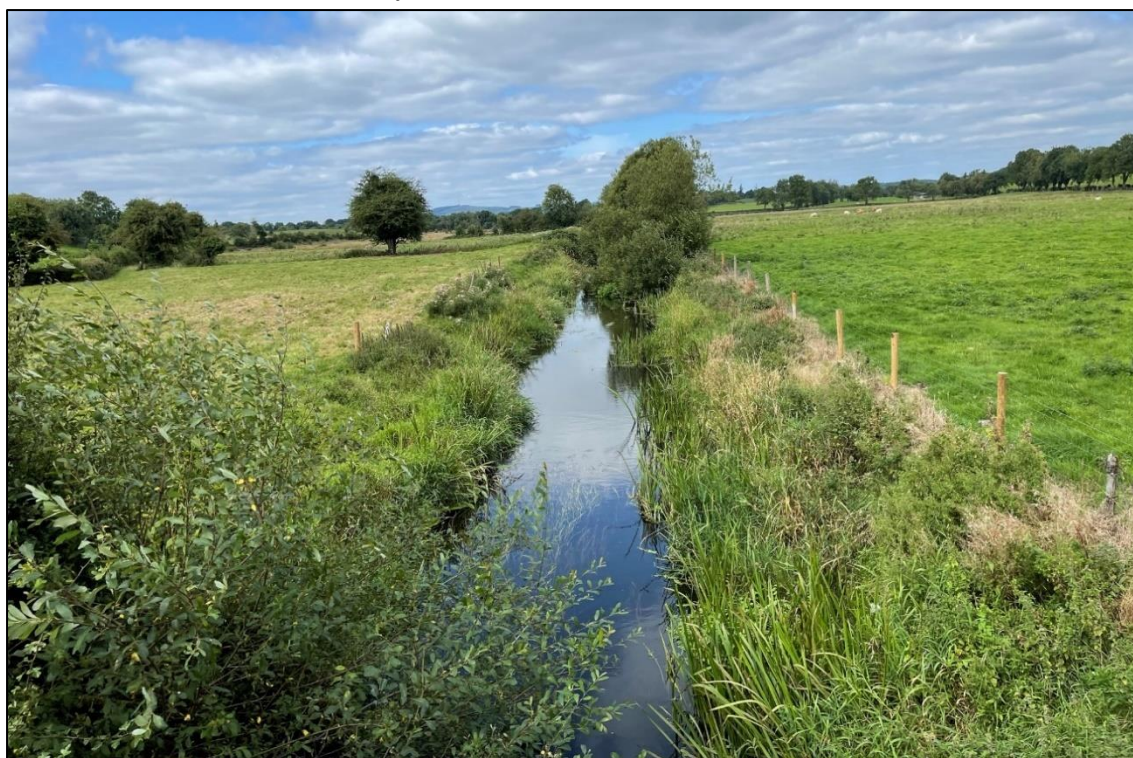
Plate 14 EPA monitoring station RS26C010050 on the River Camlin. This site was rated Q4 in 2020. This site had improved from Q3-4 in 2018.

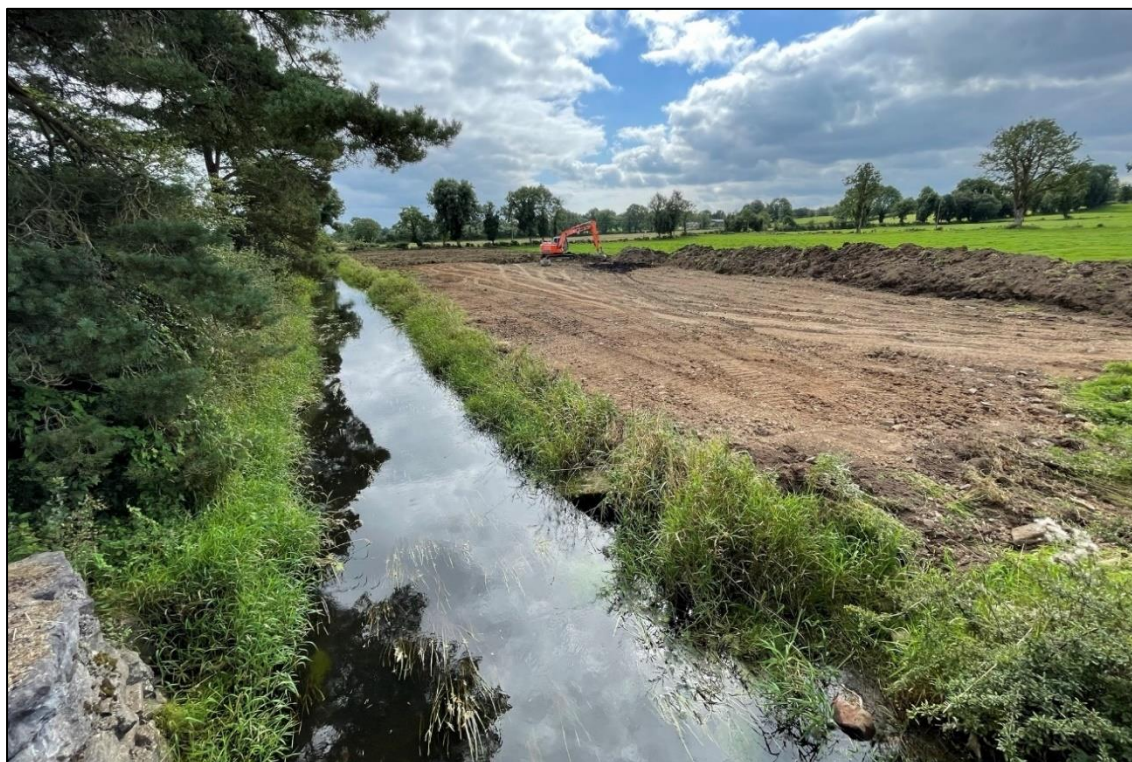
Plate 15 EPA monitoring station RS26C010050 on the River Camlin. The soil adjacent to the river had recently been cleared.

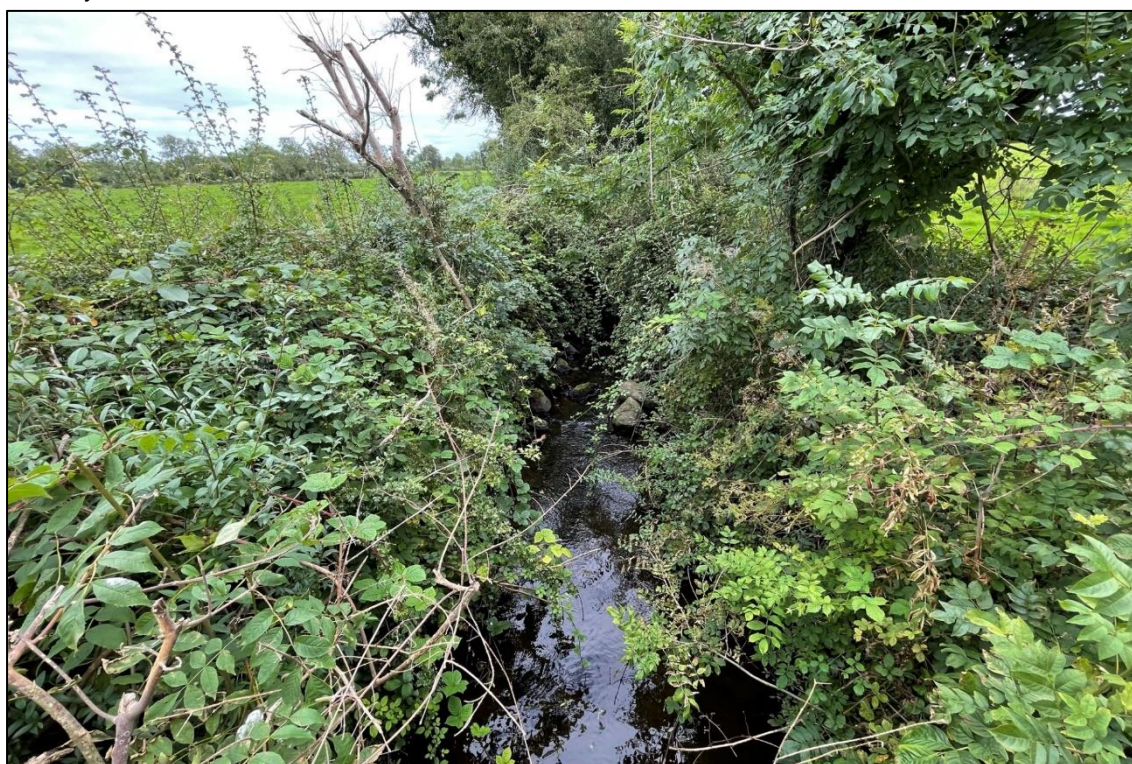
Plate 16 EPA monitoring station RS26F010020 on the River Fallan. This site was rated Q3-4 in 2020.

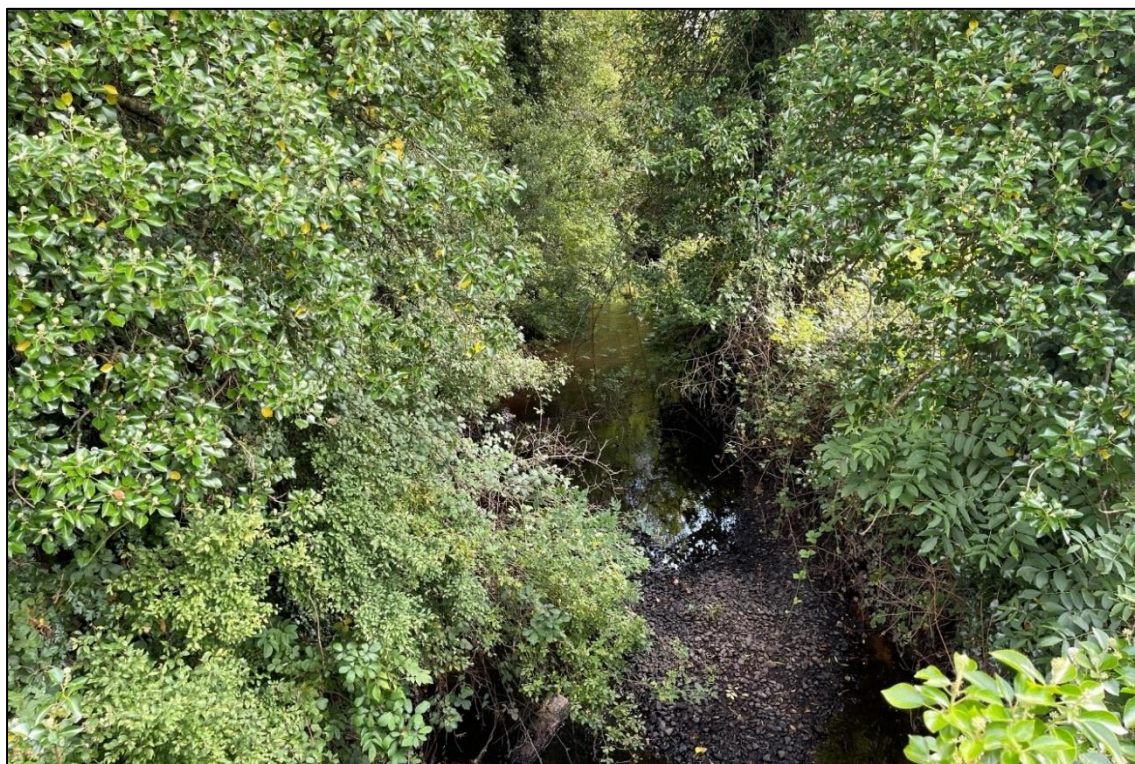
Plate 17 EPA monitoring station RS26F010040 on the River Fallan. This site was rated Q3-4 in 2020.

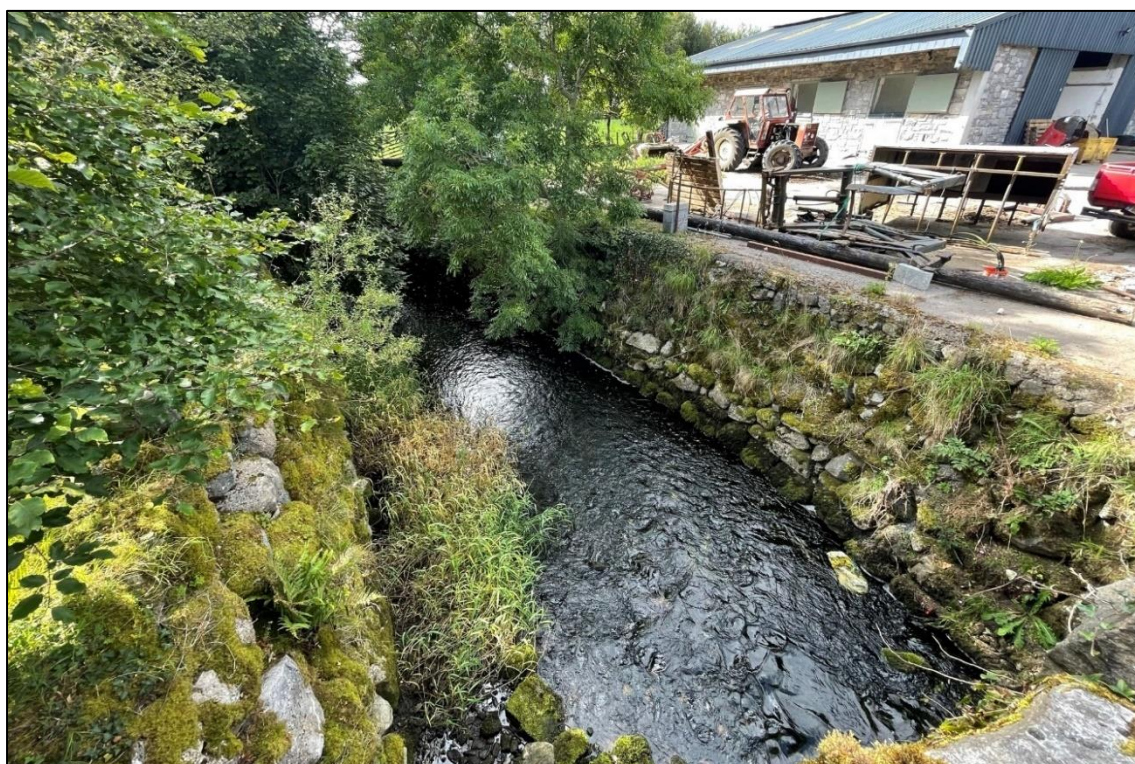
Plate 18 EPA monitoring station RS26F010200 on the River Fallan. This site was rated Q4 in 2020.

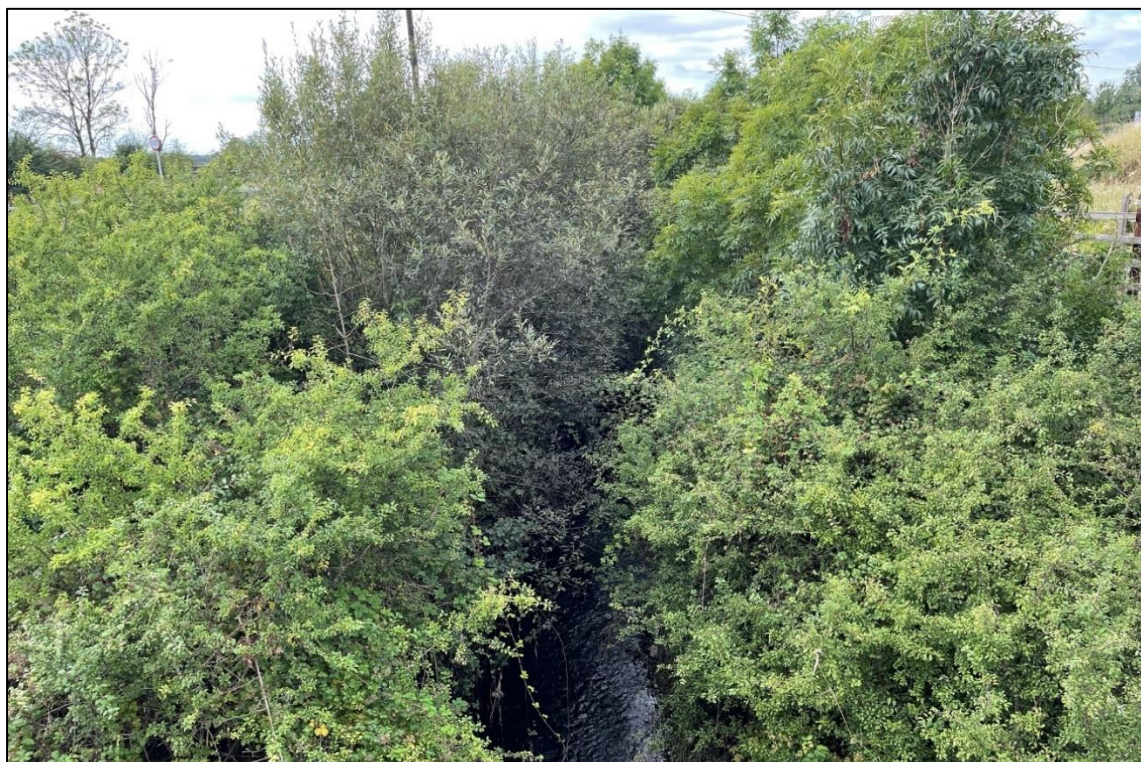
Plate 19 Site on the lower River Dash/Cloonkeen Stream. There was a recent fish kill on this stretch of river.

IFI also reported a fish kill on the waterbody named by the EPA as the Cloonkeen Stream (known locally as the River Dash). This fish kill is currently under investigation by IFI. This fish kill originated in the Stonepark area. This stream begins north of Ardagh, a town c. 11km southeast of Longford Town. This stream joins the River Camlin c. 0.45rkm upstream from where the Longford Leader (2013) reported another fish kill. The Cloonkeen Stream has been identified as a waterbody that has high levels of ammonia and phosphate (WFD, 2018b). The source of these increases are due to modifications of the channel, mainly for animal access for agriculture (WFD, 2018b). The EPA envision maps show that several coniferous plantations are situated adjacent to the Cloonkeen Stream. There is also a small urban centre located on the Cloonkeen Stream named Stone Park. Two wetlands are adjacent to this stream. One of these wetlands is the protected NHA/SAC named Mount Jessop.

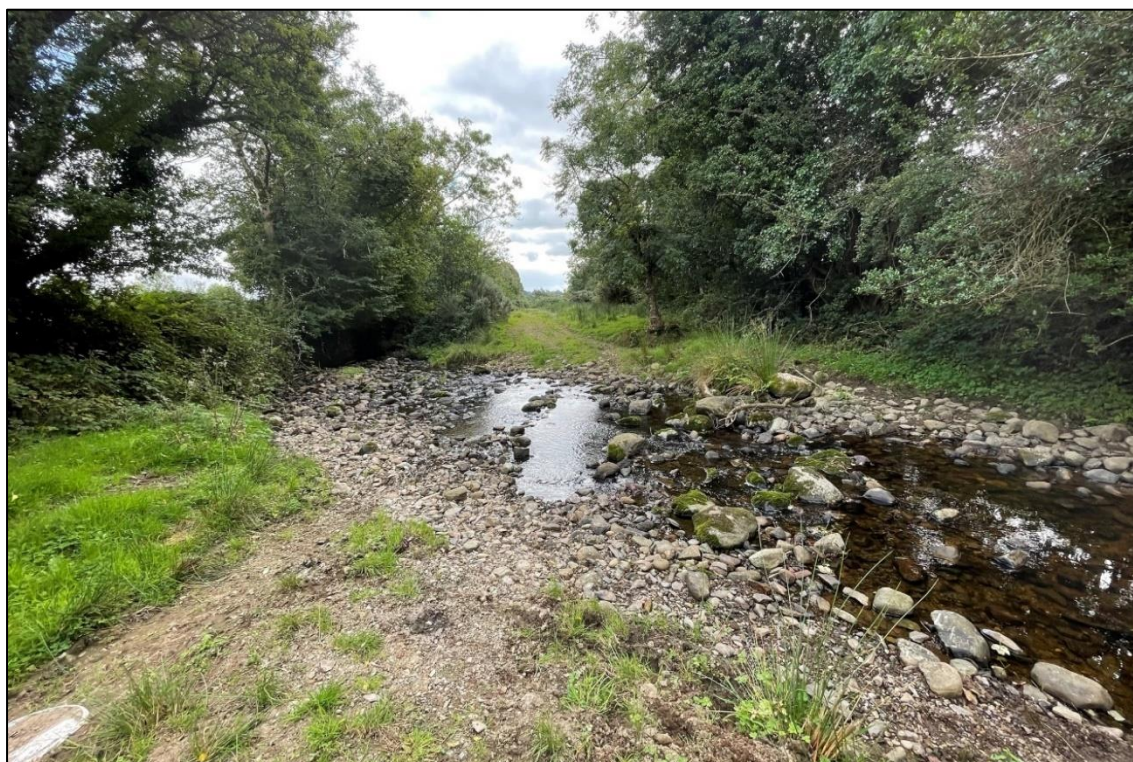
Plate 20 EPA monitoring station RS26A110300 on the 2nd order Aghnashannagh Stream. This site was rated Q 4-5 by the EPA in 2014, 2017 and 2020 by the EPA. There is a trackway in the background of the photo.

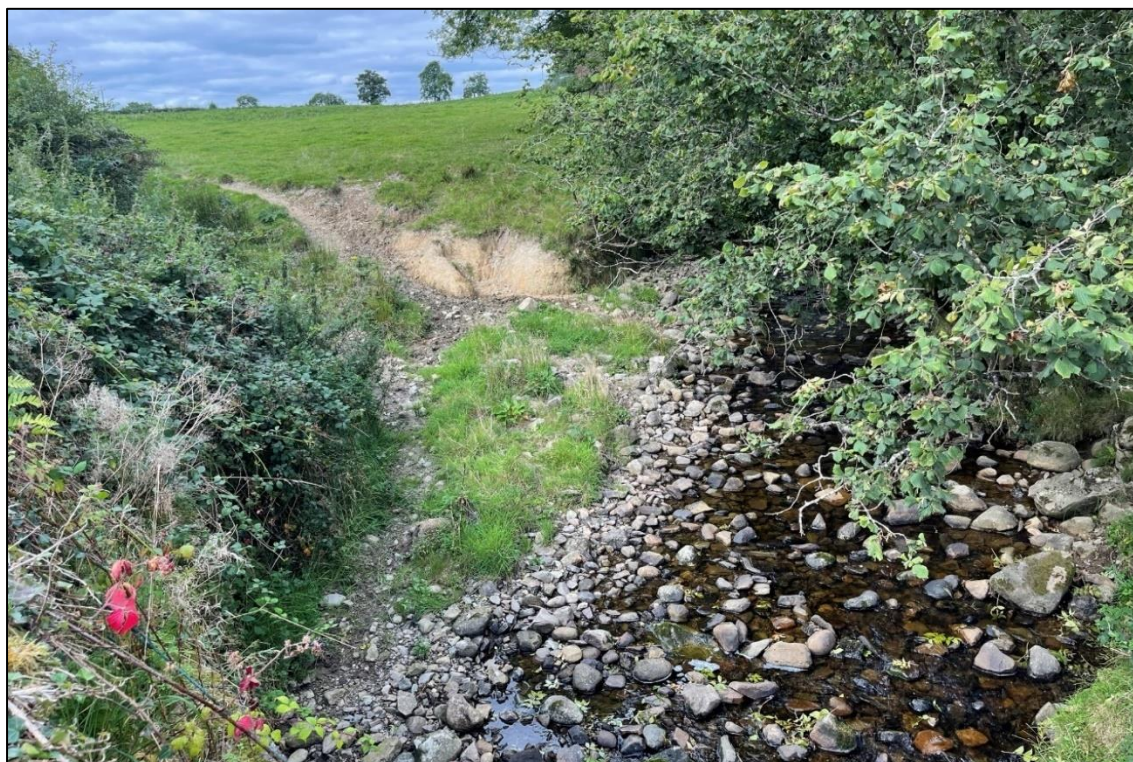
Plate 21 Evidence of cattle access and bank erosion at EPA monitoring station RS26A110300 on the 2nd order Aghnashannagh Stream.

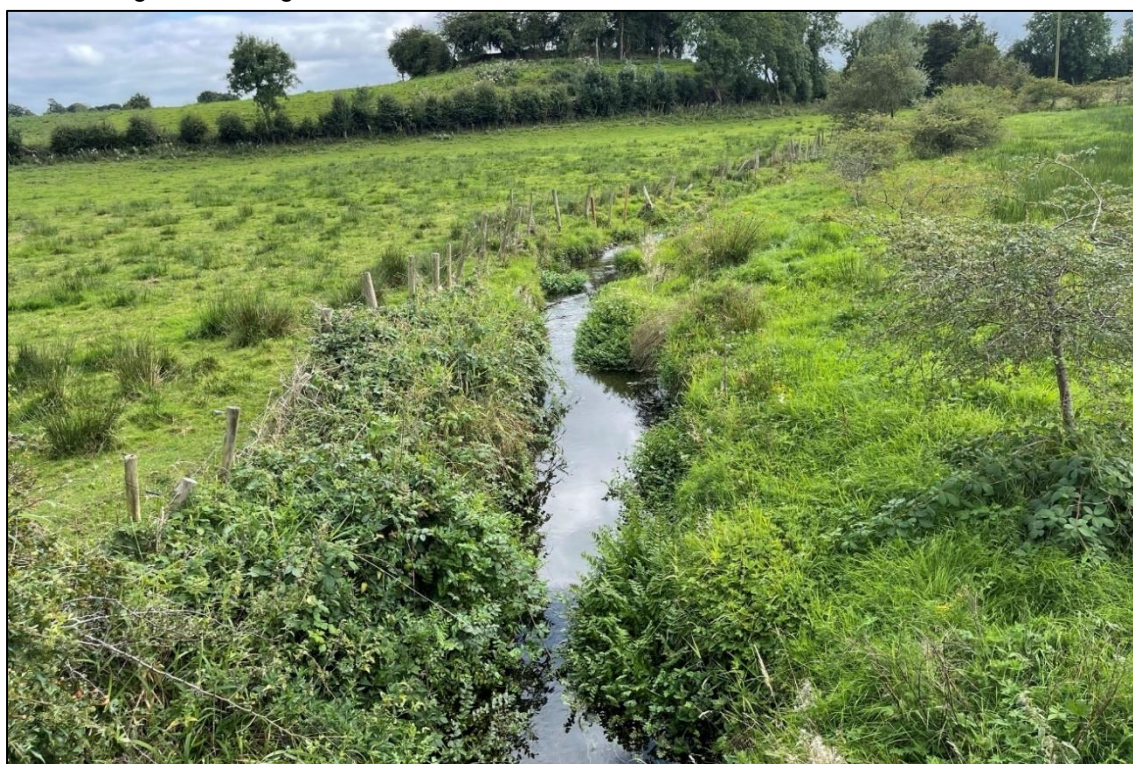
Plate 22 EPA monitoring station RS26R040700 on the River Rhine. This site was rated Q4-5 in 2020. This was an improvement on the previous rating of 3-4 in 2017.

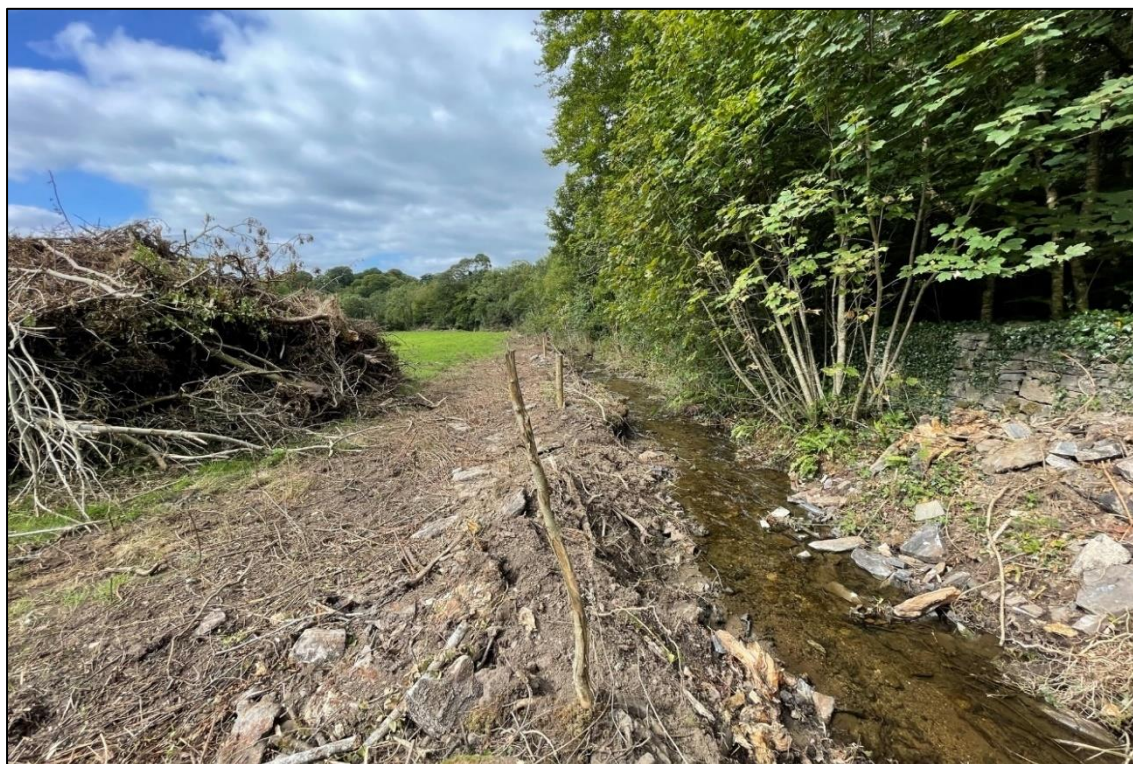
Plate 23 EPA monitoring station RS26C200300 on the Cloncoose Stream. This site was rated Q 3-4 in 2020. A large section of vegetation had recently been cleared on the riverbank.

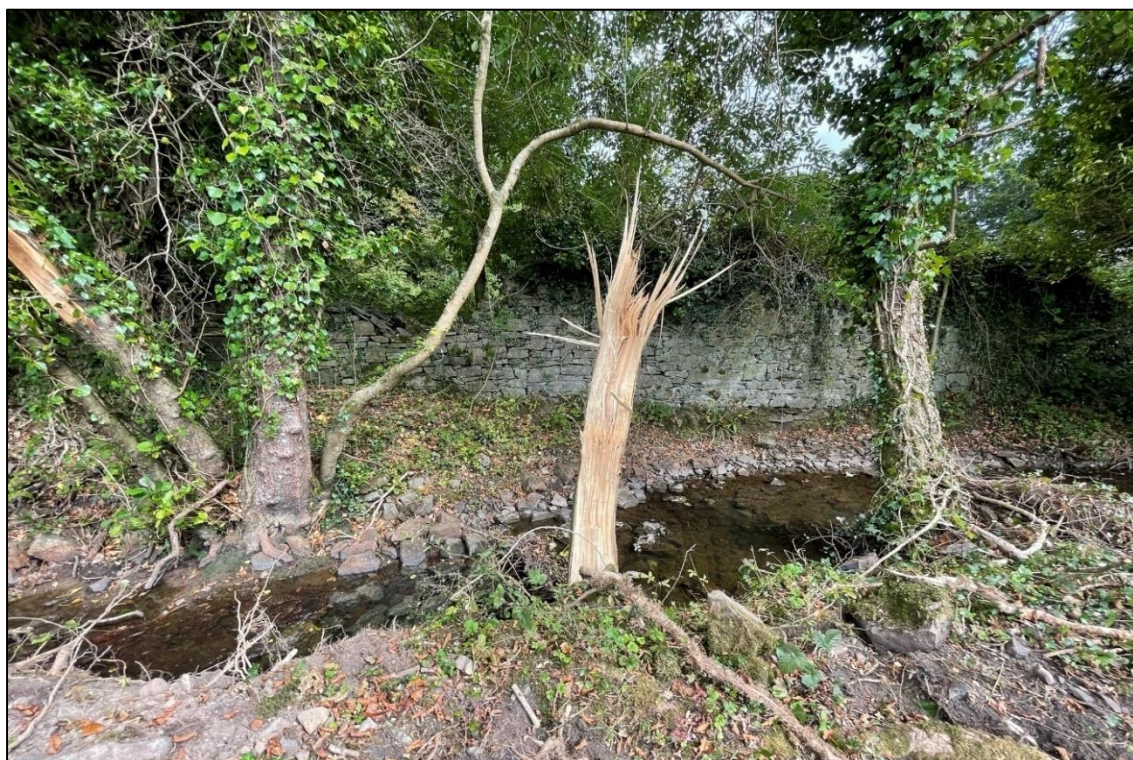
Plate 24 EPA monitoring station RS26C200300 on the Cloncoose Stream. Showing recently felled tree and area where vegetation was cleared.

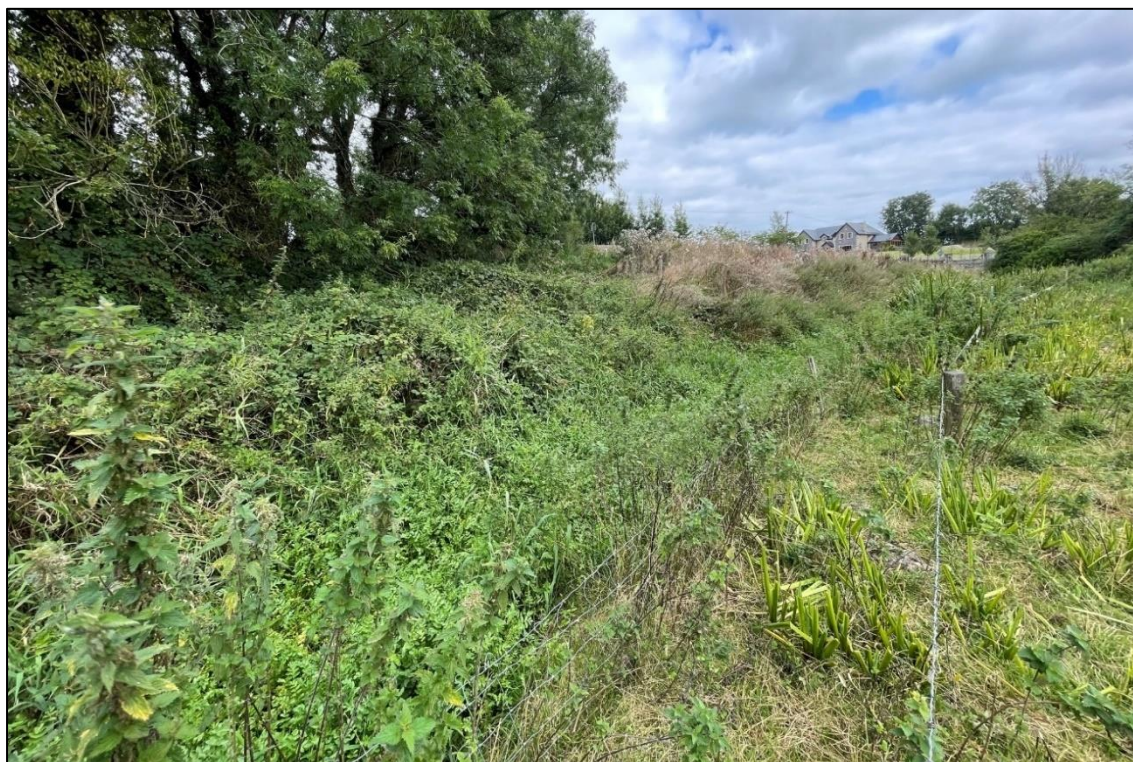
Plate 25 EPA monitoring station RS26R040200 on the River Rhine. This site was very overgrown. This site was rated Q3 in 2020, an improvement from Q2-3 in 2017
